Grafton Wastewater Treatment Plant

New construction for capital equipment retrofit and replacement. Replaced lift bar screen, collector chains, and head-and footshaft sprockets. Grafton plant has a rated capacity of 2.5 mgd serving a population of 11,500. Effluent discharged to Milwaukee River, with permit limitations of 30 mg/l BOD, 30 mg/l suspended solids. The plant achieves 90 to 99% pollutant removal.

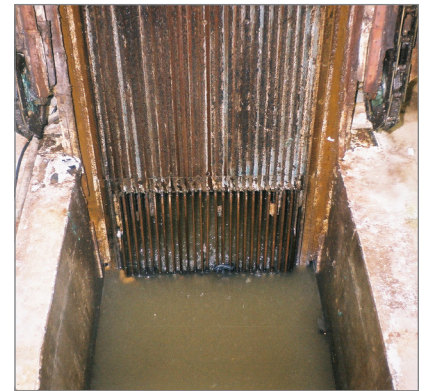
ABOVE: Rusted Bar Screen

For 20 years, Grafton had been operating a German-made lift coarse bar screen which handled Grafton’s debris-laden inflows very well. At first, when repairs were needed, the plant’s staff could make them. But as time went on, and more parts needed replacing, this became a labor-intensive and time-consuming undertaking as those parts had to be special-ordered from Germany. “We’d have to wait months for those replacement parts,” commented Tom Kreuger, Grafton’s Utility Director. As the existing bar screen with its $\frac{3}{4}$ ” screen size continued to age, downstream equipment and processes began to suffer also. Tom noticed more time was needed to clean out anaerobic digesters and related piping due to all the rags and trash that were getting through the old screen. In 2004, when Grafton wanted to upgrade its aeration capacity, “The engineers told us we needed to upgrade the bar screen or the aeration upgrade wouldn’t be successful,” Tom says. Rich Wesson, Grafton’s Plant Operator, remembers, “The screen was old and rusty. It was a ticking time bomb. We wondered every day when it would be done for good.”

Mike quickly assessed that the situation was far from a simple bar rack replacement. Not only were there special sizing and equipment requirements, but the screen carriage, chains and sprockets were also worn out. It was clear that replacing just the bar rack would not make good financial sense if the equipment carriage was going to break down soon, too. Given the age of the screen, and the amount of work a retrofit of the existing screen would require, everyone agreed to avoid quick-fix options, and instead look for reliable, durable long-lasting equipment capable of withstanding the debris the Grafton plant experienced. After a cost and mechanical equipment evaluation, Mike knew the answer to Grafton’s problems: DuraMax.
