Racine Water Treatment Plant

Rehabilitated equipment for municipal surface water treatment plant with a rated capacity of 60 mgd serving 110,000 customers.

Racine, WI

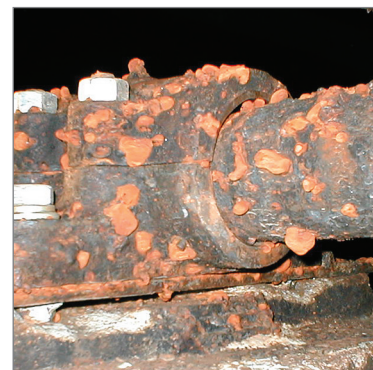
BEFORE

Squeaks and groans used to ring through the halls of the Racine Water Treatment Plant, indicating severe bearing wear and warning of impending shaft breakage. Repairing broken shafts and maintaining grease-lubricated bearings at the plant required a lot of effort. The affected basin would be shut down for four to six weeks, with three people working to fix the shafts and grease the bearings. The cost to the plant was 960 man/hours (24 man/weeks) per year. Even worse, the shafts would often break soon after being fixed.

Clearly, the old bearings had irregular wear and had developed large gaps (see below right), causing shaft instability and eventual breakage. Replacing the bearings was very expensive and would not permanently solve the problem, but postponing replacement resulted in additional costs. Broken shafts slowed water movement and caused several feet of sediment to accumulate on the basin floors, which necessitated removal and increased maintenance costs. The impaired shafts also compromised creating the energy needed for optimal mixing and floc formation, and made achieving water treatment goals challenging.

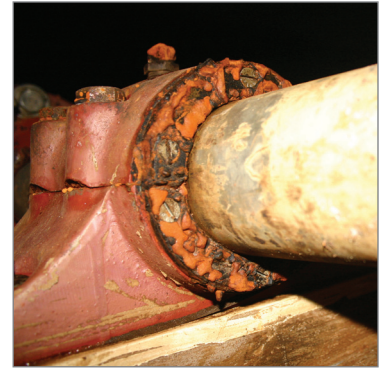
AFTER

“We likely won’t have to replace this equipment for another 20 years,” adding that the new equipment has virtually eliminated any shaft or bearing breakdown. The equipment is now reliable and capable of functioning under high stress and increased plant loads. Rick and his staff have not seen any shaft or bearing wear to date, and have been very satisfied with the experience of working with Amwell.

From the start, Amwell’s full service approach saved Rick outside contractor fees and resulted in a collaboration addressing the plant’s needs for the least amount of cost. Amwell designed the flocculation system to reuse the plant’s existing dry well drive system, while upgrading the shafts to lighter weight material, which finally solved bearing wear, shaft breakage, and related maintenance issues.
